# Evaluation of Drop-Check Structures for Farm Irrigation Systems

A. S. Humpherys

## ABSTRACT

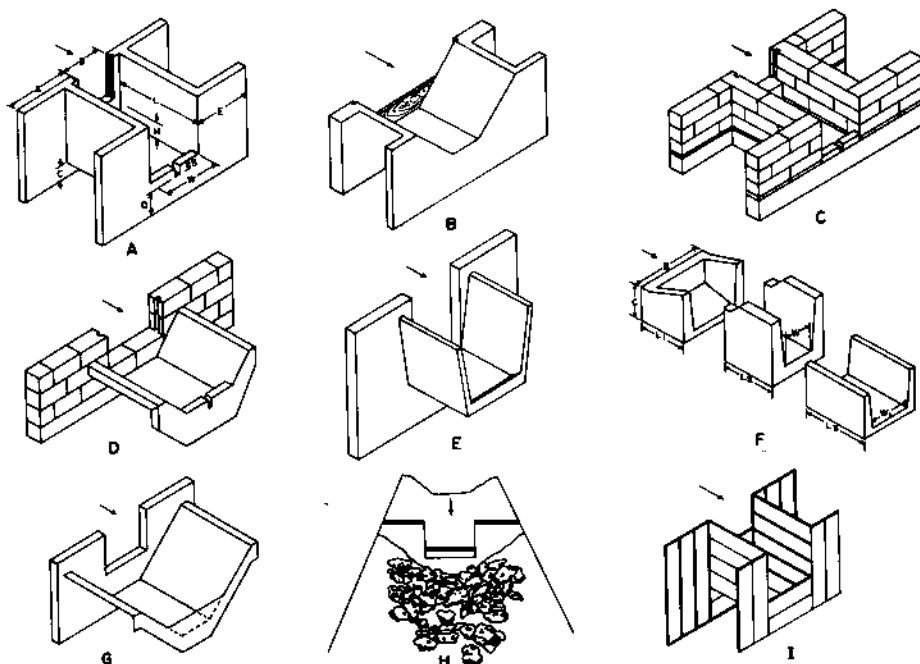
Fig. 1—Schematic drawings showing general configurations of the structures tested.

Concrete cast-in-place structures 2 to 5 (view A, Fig. 1) were generally in excellent condition in 1984. Deterioration consisted of damage to the concrete crest of No. 5 and a crack in one wingwall. The crack developed early in the study and has widened with time. The concrete is not steel-reinforced. Trapezoidal structures 19 and 20 (view B, Fig. 1), which have cutoff walls but no headwall, show no signs of deterioration except on the wooden checkboards. Concrete block structures 20 and 21 (view C, Fig. 1) show significant damage from weathering. The concrete cap on top of the blocks is cracked and has started to spall (chip and crumble); some of the crest and end sill blocks are cracked and chipped; blocks at the base of the sidewalls are spalling and have cracked longitudinally such that the sidewalls are separating from the basin floor. Some of this deterioration occurred during the initial study period, but has since increased. The headwalls on both structures have separated from the sidewalls as shown in Fig. 3. Steel reinforcing was used in the blocks but was not used to tie the sidewalls to the headwall. Concrete blocks that cannot dry before freezing weather may have a shorter life than concrete in climatic zones with severe winters. The blocks are subject to greater freeze-thaw damage than is concrete. Trapezoidal structures 25 and 26 (view D, Fig. 1) have concrete block headwalls and cast-in-place stilling basins. Separation of the headwalls from the basins began during the initial study but has increased since. A longitudinal crack in No. 25 which developed early in the study from backfill settling has widened, Fig. 4. The concrete cap on the blocks is

Precast structure No. 6 (view E, Fig. 1) is steel-reinforced and is in good condition. Precast structure No. 7 (similar to view E, Fig. 1) is not steel-reinforced and the concrete is beginning to crack such that spalling will follow in due time. Longitudinal cracks have developed at the base of the sidewalls. The concrete in precast cofferdam structures 8, 9, and 10 (view F, Fig. 1) is cracking and spalling in places while other parts of the structures appear sound. Since the concrete is not reinforced, the cantilevered walls are generally not strong enough to resist soil forces; they tend to crack at their base and lean inward. Because the individual component sections are not tied together, they can move independently and do not lend structural strength or support to each other. Most of the concrete in the larger structures, 27 to 29, is sound with some spalling on the cofferdams. The sidewalls of No. 29 have separated from the main structure and sloughed into the ditch.

Structures 11 to 16 (views G and H, Fig. 1) have relatively thin, precast concrete headwalls that were steam-cured and reinforced with steel. These are relatively light weight and durable with no evidence of deterioration. Structures 11 and 12 had fiberglass stilling basins. The basins had begun to separate from the headwall during the initial study period and some of the edges and corners had begun to crack and chip. During the intervening time period, the basins disappeared and the headwalls are now functioning alone. The fiberglass could possibly have caught fire and burned when weeds on the ditch banks were burned. Structures 13 and 14 have sheet metal stilling basins formed from 22-gauge galvanized steel ditch liners. The basins are still intact; however, one of them is somewhat deformed and has a damaged end sill (14-gauge steel) while the other is in good condition.

Modular steel structure No. 23 (view I, Fig. 1) appears sound except where the galvanizing is wearing off with resultant rusting. Aluminum structures 24 and 30 are missing; however, observations made on similar structures that have been in service for comparable periods of time indicate that the aluminum alloy material is durable, resistant to weathering and is not adversely
